## SERVICE TECHNICAL INFORMATION

### ONE POINT REPAIR

REF. NO.: S1-97-012

MODELS: AM-F3

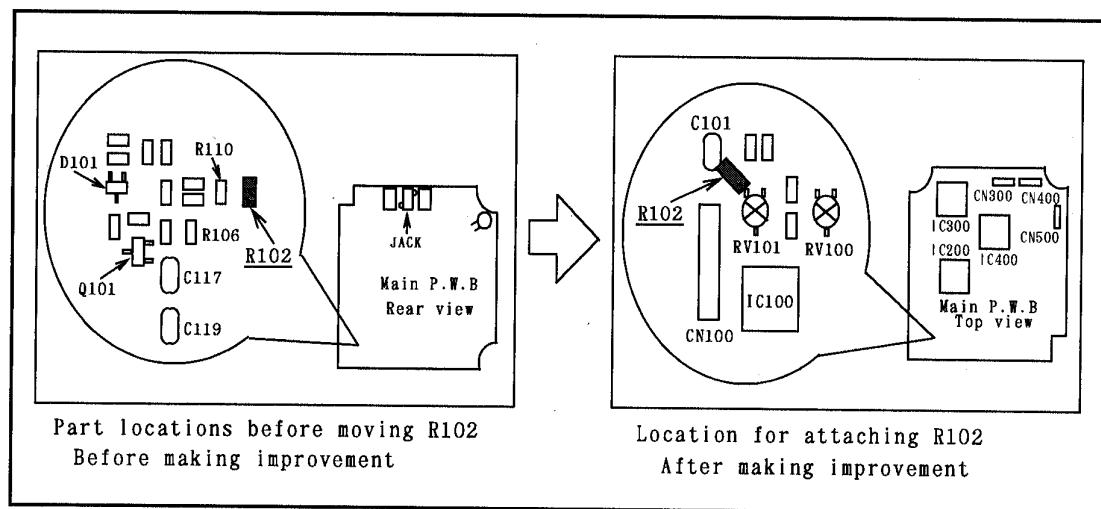
The PICK UP flexible cable is located between the PICK UP main body (mechanism section) and the main board. When a shock or vibration is applied to the set, the mechanism will momentarily lower causing the PICK UP and board to press against the flexible cable.

It is likely that the cornered section of R102 (chip resistor) on the board causes damage to the flexible cable.

METHOD: Change the position of R102. Change the flexible cable so that stress will not be applied even when pressing against the cable. Remove R102 from the rear side of the board (prescribed position), and connect (line) between the C101(+) terminal and RV101 on the front side of the board. (See the figure below.)

**Note:** After moving R102, there may be some sections of solder remaining at the location from which the resistor was removed. If this solder remains, it is likely to cause similar faulty operations. Always confirm that all of the solder has been removed after removing the resistor.
