**AIWA CO.,LTD
UTSUNOMIYA FACTORY**
2620, TOKUJIROU-MACHI, UTSUNOMIYA-SHI, TOCHIGI 321-21, JAPAN

SERVICE TECHNICAL INFORMATION

ONE POINT REPAIR

REF. NO. : SI-96-032

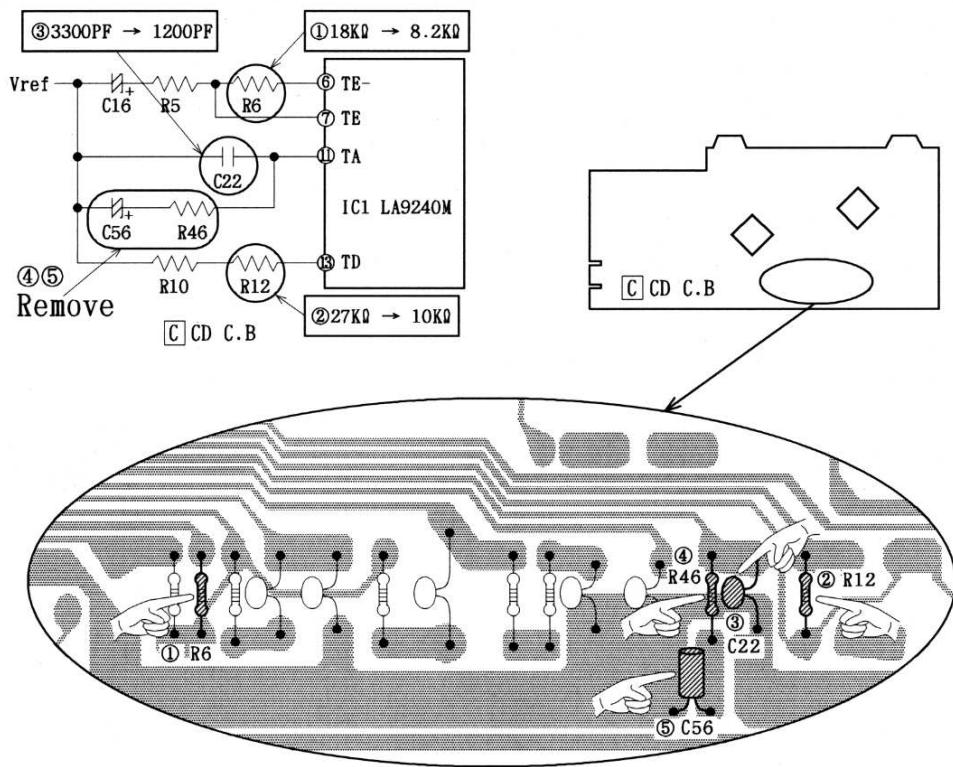
MODEL : NSX-E5M
SUBJECT : Does not read CD TOC, does not play
SYMPTOM : Occassionally the CD TOC is not read, or the set does not play. If such a problem is indicated by the customer, perform the following remedy.

REMEDY : 1) Replace the R 6 18KΩ with an 8.2 KΩ.
2) Replace the R12 27KΩ with a 10 KΩ.
3) Replace the C22 3300PF with a 1200PF.
4) Remove the R46 2.7 KΩ.
5) Remove the C566 0.47μF/50V.
