# Service Technical Information

| MODEL NO. | XR-MD85 EZ |
| SUBJECT | Tape stop at FM recording |

REF.No. :G - 99 - 047 - E0

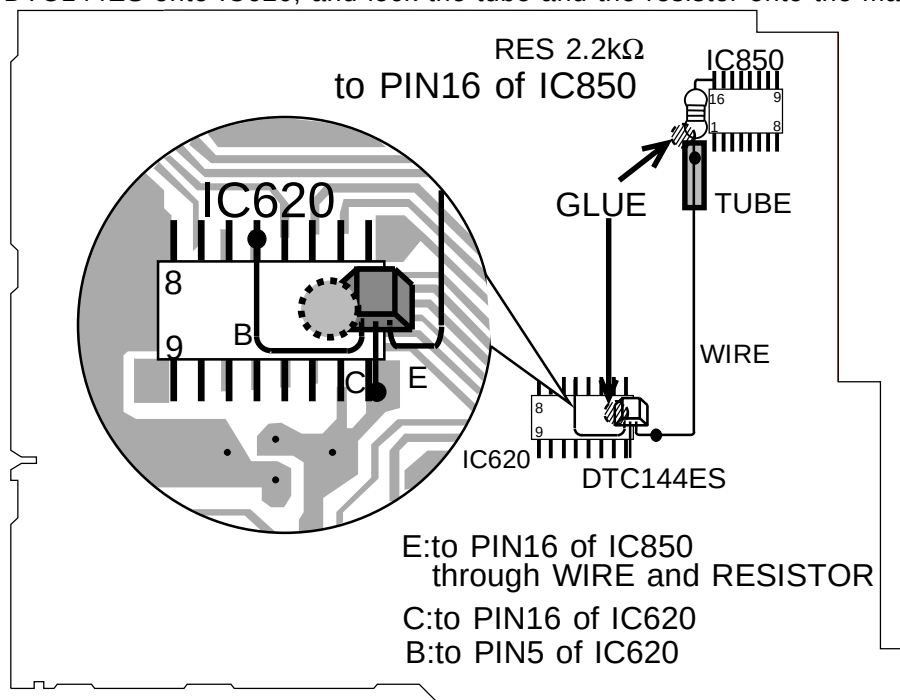
## MAIN C.B. PATTERN SIDE

A tape stops in approximately 5 minutes after starting recording of an FM program on tape, using the model in question.

This problem occurs when an FM signal includes RDS signal.

1. Solder the base terminal of DTC144ES to pin 5 on IC620, and solder the collector terminal of DTC144ES to pin 16 of IC620.
2. Solder the emitter terminal of DTC 144ES to the wire, and let the wire in the tube.
3. Solder an end of the wire to the resistor.  
Solder the other end of the resistor to pin 16 of IC850.
4. Lock DTC144ES onto IC620, and lock the tube and the resistor onto the main C.B. with glue.

After taking the above actions, RDS indication will not be updated during REC operation on tape.
