SERVICE BULLETIN: 02001-2

Date 01/30/02

Models:	TX-DS797 / TX-DS898
Symptom:	Static like Noise (tic, tic,) occurs when in surround mode with a limited possibility of Surround Back not functioning.
Cause:	Power Supply VCC for Q713 may be too high.
Solution:	Reduce VCC or Replace Q713. Must Perform Bulletin 02002-2 For <u>Dolby Digital Audio Drop Out</u> as well.

SERVICE BULLETIN: 02002-3

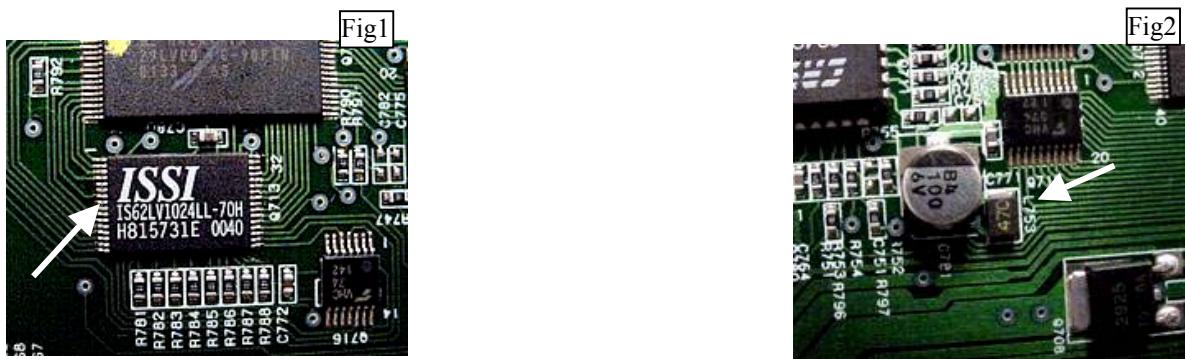
In some units Q713 IC, brand **ISSI**, IS62LV1024LL-70H was used [Fig1], where as in some NEC MPD441000LGU-B70X may be found. For those units using the **ISSI** SRAM and having the above aforementioned problem, you will need to replace the IC Q713 with PN#22241793R3 having NEC MPD441000LGU-B70X or Mitsubishi M5MV108DKV-70H brand label. If above part is to be replaced L753 need not be replaced. See Note.

For units having not developed such problem and has the **ISSI** IC in place, it is highly recommended that L753 [Fig2] be changed to 33Ω (PN#433223304R1) chip resistors and need not replace IC.
