## SERVICE BULLETIN: 02001-2

| Models: | TX-DS797 / TX-DS898 |

SERVICE BULLETIN: 02002-3

Models: TX-DS595, TX-DS696, TX-DS797, TX-DS898

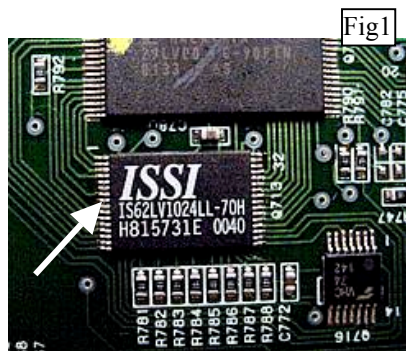
| Symptom: | Static like Noise (tic, tic,) occurs when in surround mode with a limited possibility of Surround Back not functioning. |
| Cause: | Power Supply VCC for Q713 may be too high. |

In some units Q713 IC, brand **ISSI**, IS62LV1024LL-70H was used [Fig1], where as in some NEC MPD441000LGU-B70X may be found. For those units using the **ISSI** SRAM and having the above aforementioned problem, you will need to replace the IC Q713 with PN#22241793R3 having NEC MPD441000LGU-B70X or Mitsubishi M5MV108DKV-70H brand label. If above part is to be replaced L753 need not be replaced. See Note.

| Solution: | Reduce VCC or Replace Q713. Must Perform Bulletin 02002-2 For <u>Dolby Digital Audio Drop Out</u> as well. |
