## **Service Bulletin**

**No. :** MZ04-005

**Model:** CD5400

**Subject:** Jumping sound sometimes occurs during CD playback.

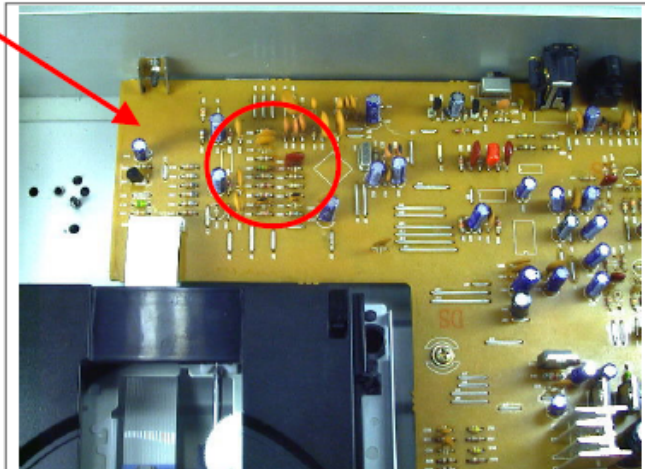
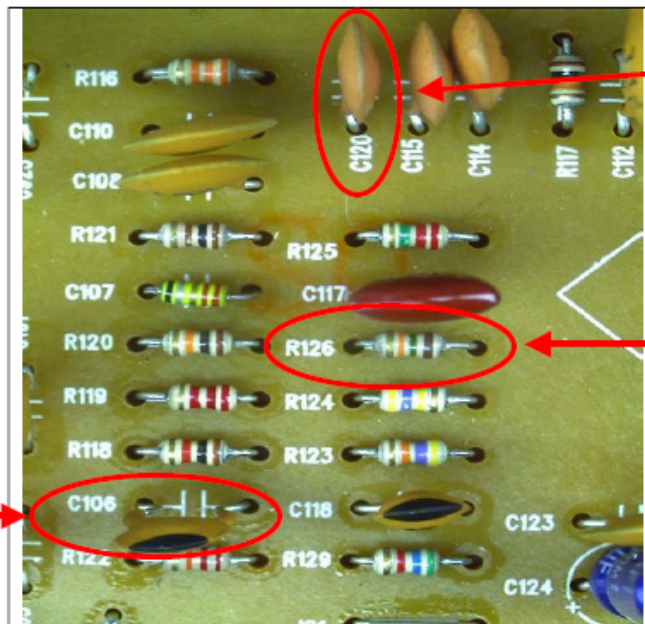
**Symptom:** When playing back a high Jitter Disc, the sound can jump (skip). However, if you return to the place where the sound skipped and play the track again, it does not skip.

C120

R126

C106

**Solution:** Replace the following parts located on the MAIN PCB and FRONT PCB.

1. Ceramic capacitor C106 (56pF) is changed to 68pF.
2. Plastic film capacitor C120 (0.01uF) is changed to 0.1uF.
3. Carbon film fixed resistor R126 (15K ohm) is changed to 6.8K ohm.
4. Replace MICRO PROCESSOR IC71.

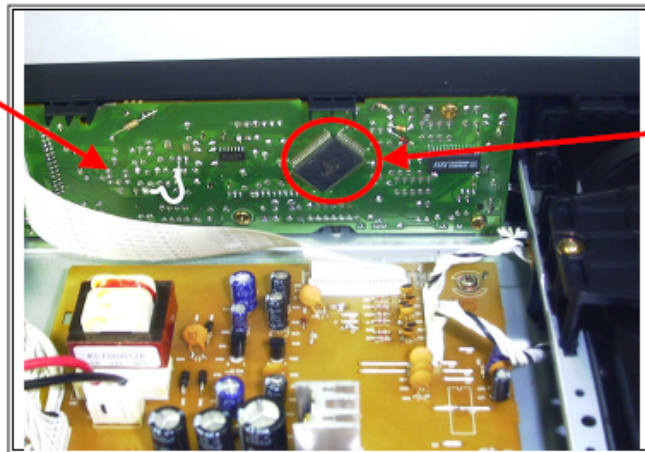
FRONT PCB

IC71
