<b>marantz®</b> <b>SERVICE BULLETIN</b>		Date: 17-Jul.-2002	Model: PM4200
		Page: 1/2	REF.NBR: MZ02-009revision
Subject:			Problem with incorrect operation of MUTE.
			Int.ref:
Circulation:	Application:		
<input checked="" type="checkbox"/> for information customer complaint in case of service mandatory .....	See below

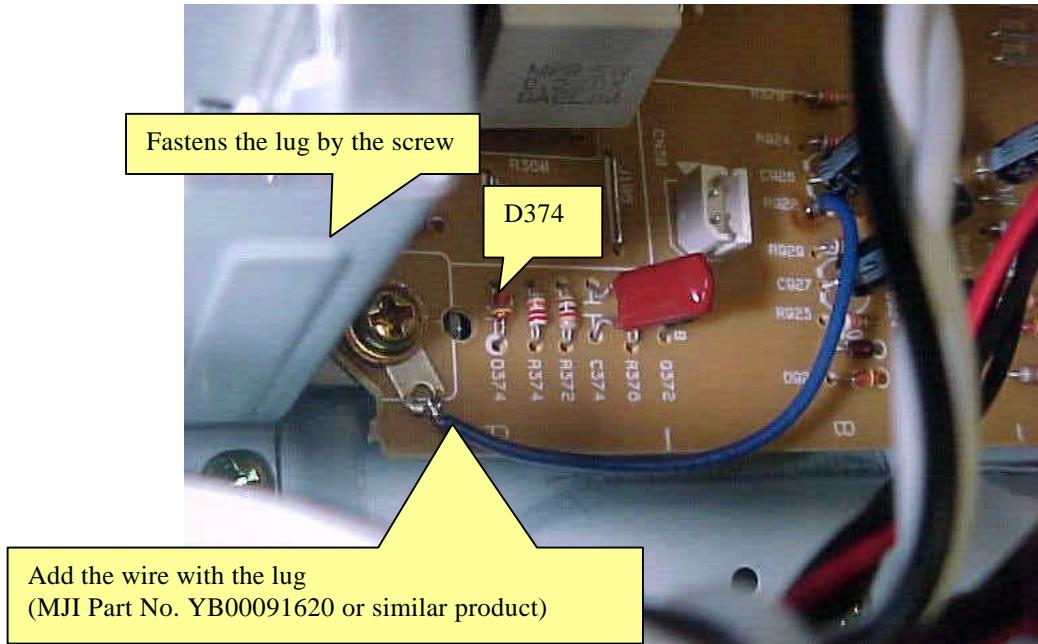
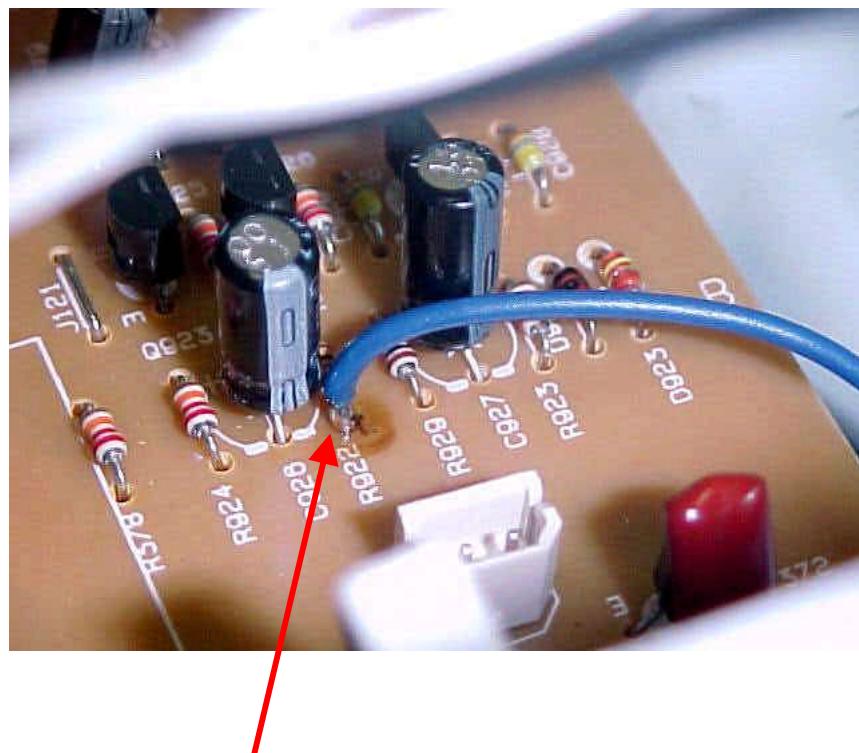
Processing figure (Part side view)

The MUTE LED sometimes blinks and the sounds from output intermit.

Contact error between the bracket (Pos. No. 30) and the ground of INPUT/AMPLIFIER PCB (Pos. No. 29).

Contact to the ground certainly by the wire with the lug.

**Solder the wire to the ground side lead of the R922 or R929**
