Service Bulletin

No. : MZ08-043

Model: PM5003

Subject: The protection operation cannot be deactivated.

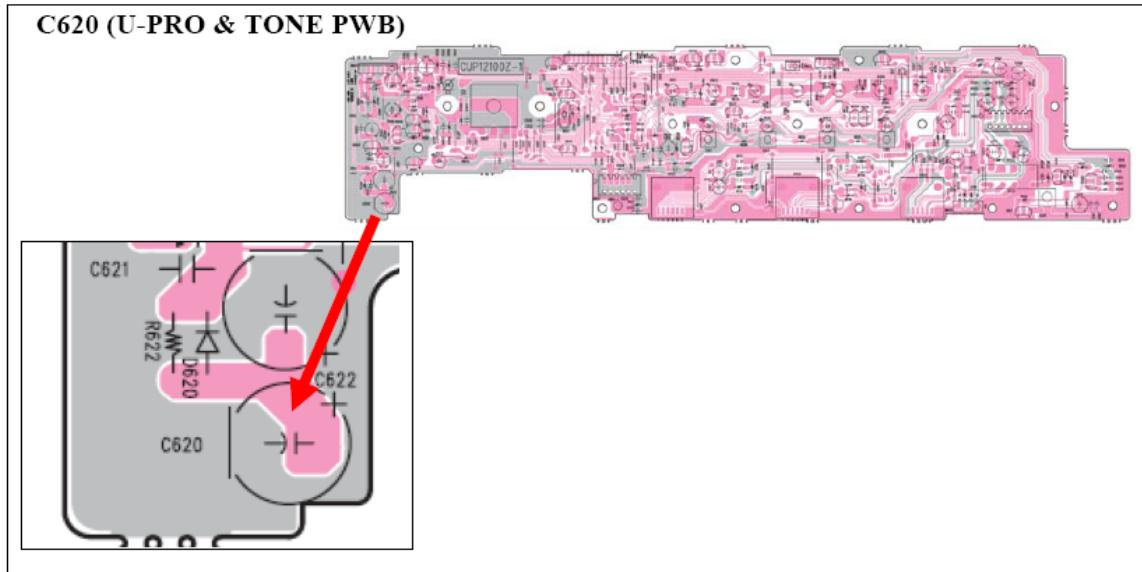
Symptom: The protection operation cannot be deactivated by the Power Switch being turned OFF/ON. If a problem is detected while the AMP is in operation, the STANDBY LED starts flickering and the operation is ceased. If the problem is no longer detected, the protection operation can be normally deactivated by turning the power OFF and then ON. However, in this case, the STANDBY LED cannot be stopped from flickering, depending on the timing of the power switch being turned OFF/ON.

- Clear the protection operation procedure in the RAM by shorting the backup capacitor C620. After deactivating the protection operation, ensure that none of "DC Offset", "DC Balance" and "Over current" (Speaker Short-out) is detected.
- If no abnormality is found with the amp, the protection operation may have been activated by over current caused by a shot-out of the speaker cable. Before returning the repaired unit, please be sure to check how it was used to a customer.

- The backup capacitor is capable of storing data in the RAM for up to one week. If the unit comes in for repairs more than one week after the phenomenon has occurred, please understand that no pertinent data may be available for the phenomenon.
