## Service Bulletin

No. : MZ05-032

**Model:** SA8400, SA-11S1, SA-15S1, DV9500

**Subject:** Improvement of Disc vibration

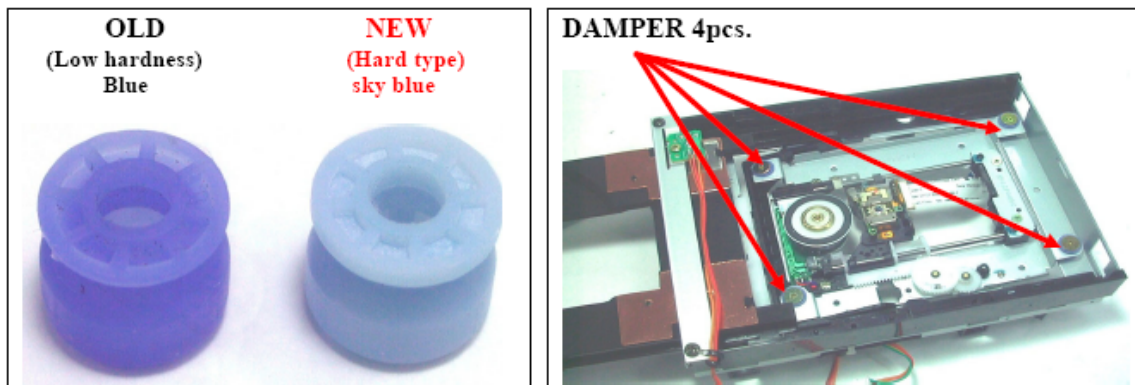
**Symptom:** During playback, an eccentric or off center Disc will cause the unit to vibrate.

**Solution:** Replace the 4 traverse Mechanism Dampers to the new hard type.
