Service Bulletin

No. : MZ08-001

Model: SA8260

Subject: QY61 is damaged, and FLD does not turn on.

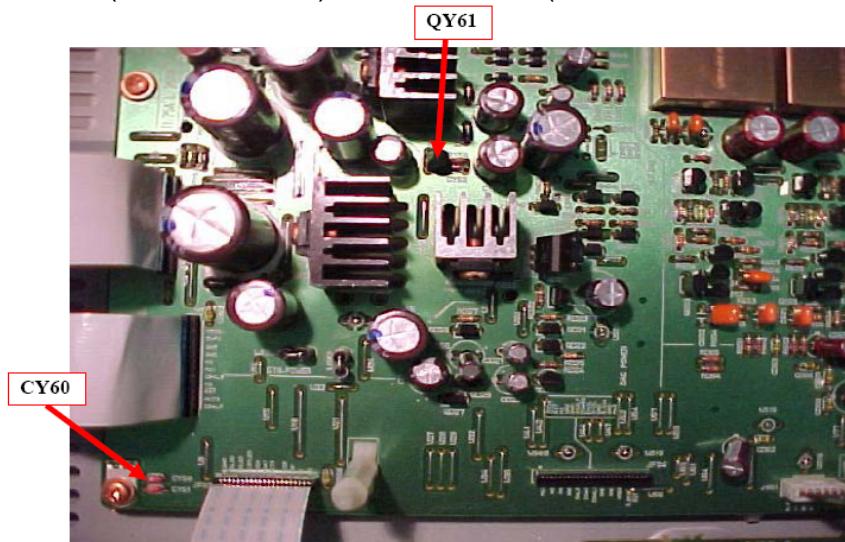
Symptom: QY61 may break down from an excess collector current generated by CY52 discharging electricity when the M1/M2/-VF line and the GND short out. The short out can be caused at the time of production or servicing, or even when the power is off, by JF03 being improperly pulled out or inserted at an angle or by the mechanical chassis hitting the front PCB. Long-term use in this condition will lead to a breakdown of QY62.

Solution: 1) When the unit is dismantled for the mechanism or the PWB to be replaced, please discharge CY52 of charged electricity by contacting a 220-ohm resistor with both ends of CY60 on PP16 (POWER/AUDIO L R CIRCUIT BOARD) for 2 seconds or more.

2) Replace QY61 (2SA1048, etc.) with 2SB1240 (00MHT212402A0: IC max, 3A).
