**Service Bulletin**

**No. : MZ07-039**

**Model:** SR6001

**Subject:** Software Update Information.

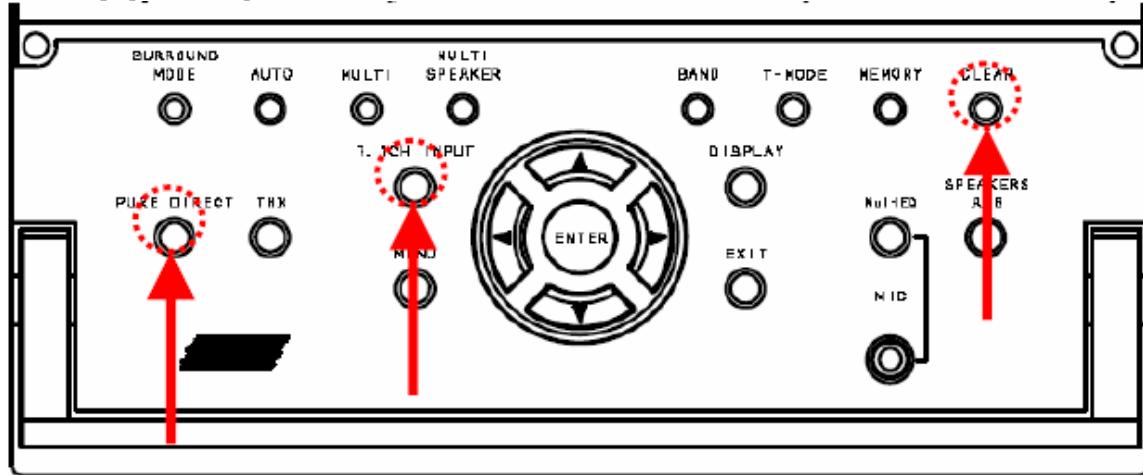
**\*1: If the unit cannot be powered on after being plugged in again (with the STANDBY LED flickering every 125m seconds), the power amp has failed. The unit still can be powered on again through the following method, but it can further damage the power amplifier. Please never let end-users perform this procedure.**

Can be powered on by “FACTORY KEY” = [PURE DIRECT]+[7.1 CH INPUT]+[CLEAR]
