Service Bulletin

No. : MZ10-052

Model: SR7005

Subject: Adding a Knob spring.

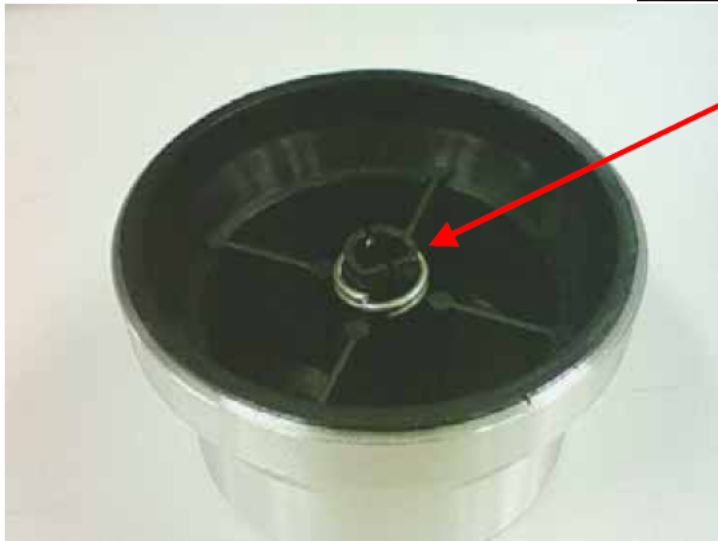
Symptom: The force of pulling of Volume/Selector knob might be weak.

Solution: Add the Knob spring to the knob shaft.

Insert SPRING to bottom of knob.
