## **Service Bulletin**

**No. :** MZ07-040

**Model:** SR7001, SR8001

**Subject:** Software Update Information.

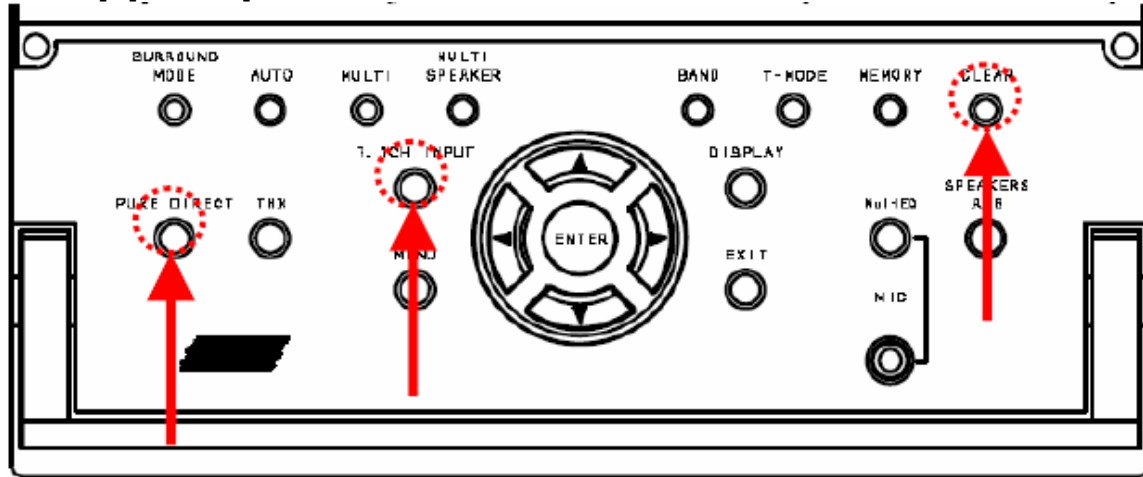
**\*1: If the unit cannot be powered on after being plugged in again (with the STANDBY LED flickering every 125m seconds), the power amp has failed. The unit still can be powered on again through the following method, but it can further damage the power amplifier. Please never let end-users perform this procedure.**

Can be powered on by “FACTORY KEY” = [PURE DIRECT]+[7.1 CH INPUT]+[CLEAR]
