## SERVICE TECHNICAL INFORMATION

REF. NO. : SI-95-011  
CUSTOMER RELATION & SERVICE DIV.

MODEL : AM-F1

SUBJECT : "Caution" during play/record

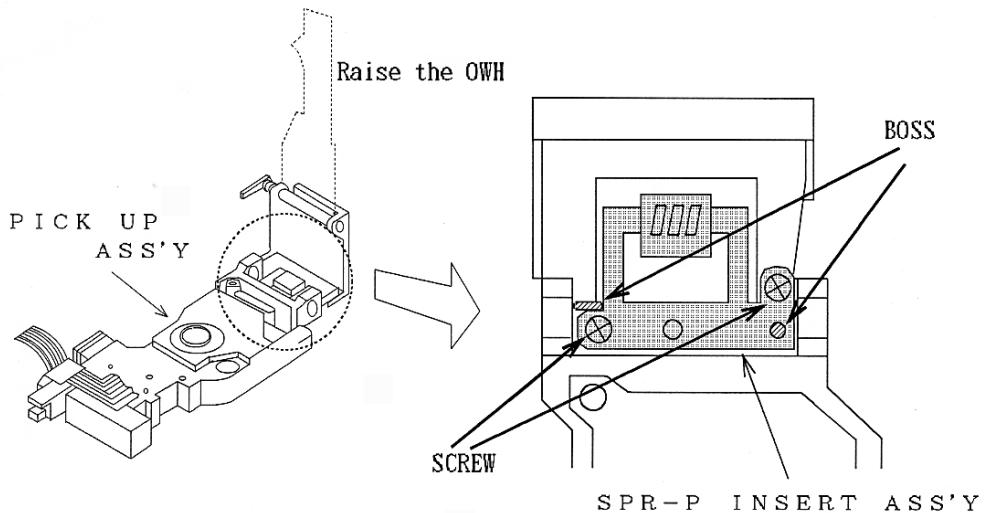
CONTENTS: Due to a faulty thread system in the AM - F1 model. "Caution" appears during play-record.

SYMPTOM : Caution is indicated during play/record, or 5~6 seconds after start play back. Also, the set can not work when placed on stand the set (input/output terminal facing up).

REMEDY : Repair by following the steps below.

- (1) Disassemble the set and remove the PICK UP ASSY. (Always short the short round of the PICK UP flexible wire.)
- (2) Remove the faulty SPR-P INSERT ASSY from the PICK UP ASSY.
- (3) Insert a new SPR-P INSERT ASSY between the two bosses and secure with screws.

**Note:** If the SPR-P INSERT ASSY is secured with screws after being incorrectly inserted between the bosses, it may become deformed and the above symptoms will recur. Pay careful attention when inserting the SPR-P INSERT ASSY.

Ref.	Parts Name	Parts No.
—	SPR-P, INSERT ASSY	87-046-415-010
