## SERVICE TECHNICAL INFORMATION

### ONE POINT REPAIR

UTSUNOMIYA, OCTOBER 15, 1997  
REF. NO.: SI-97-034  
CUSTOMER RELATIONS & SERVICE DIV.

MODEL : DX-Z9450M

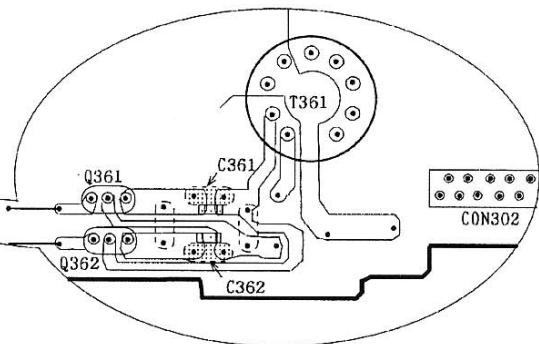
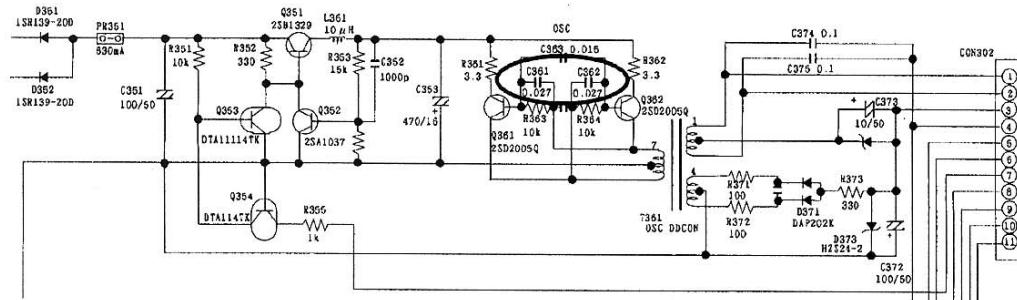
PT C.B Pattern side

DESCRIPTION : The above model may have a defect which causes no display being shown.  
Take the following action against the problem.

REMEDIES : TAITSU-product or NISSEI-product mylar capacitors C361 & C362  
(0.027μF/50V) are employed in the PT PWB. Replace TAITSU capacitors  
with NISSEI capacitors regardless of presence/absence of the above problem.  
\* Manufacturer-name indication on capacitors:

TAITSU product:

A circle "O" is  
printed on the product.

NISSEI product:

A character "N" is  
printed on the product.
