## SERVICE TECHNICAL INFORMATION

### ONE POINT REPAIR

REF. NO.: SI-97-059

MODEL S : XR-AKH100, NSX-KH9, AKH8

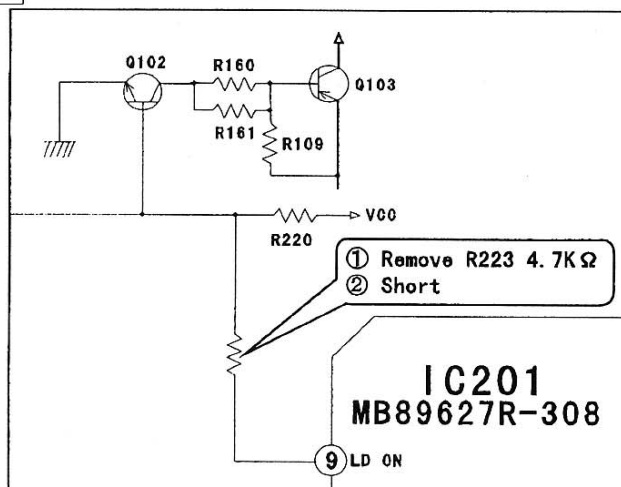
#### E CD MAIN C.B

SUBJECT : The laser pickup is always on.

DESCRIPTION : During the CD function, it is found that the laser pickup is always on regardless of CD STOP.

- REMEDIES : 1) Remove R223 shown in the circuit diagrams (CD MAIN C.B) indicated below.
- 2) Short the patterns on both sides of R223.
