## **Service Bulletin**

**No. :** MZ02-012

**Model:** SA8260

**Subject:** Problem with playability of CD single

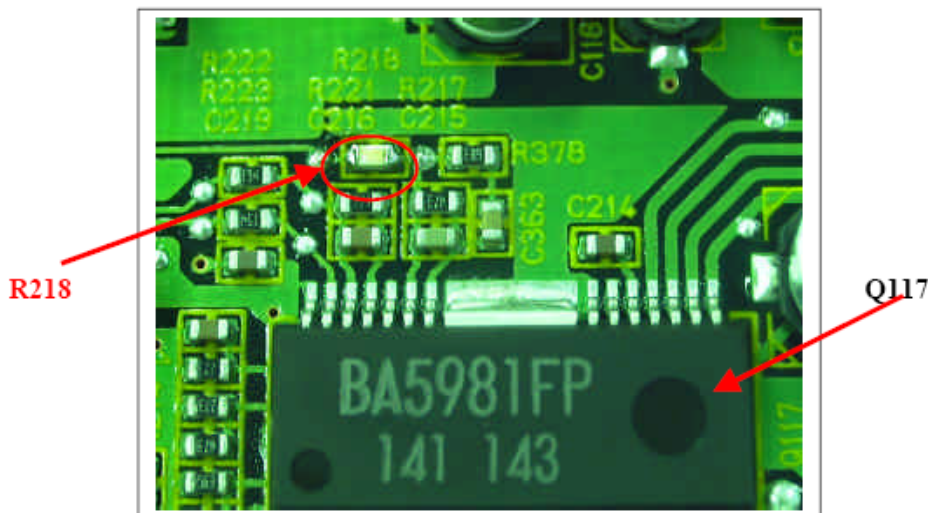
**Symptom:** Dropout is heard in the outer circumference of CD single (8cm, 3inch). This problem is noticed when the record time of the single CD is more than 20 minutes.

**Solution:** If the LOT number is from 01 to 05 and the number of [PV16] PCB is "WI01AK100-0", (The LOT number is "##" of serial number "MZxxxxxx##xxxx".) Please apply the following solution. -Replace the chip resistor [R218] <27k ohm> with <30k ohm>.
