Service Bulletin

No. : MZ02-017

Model: SR7200

Subject: Pop noise when powering the set ON.

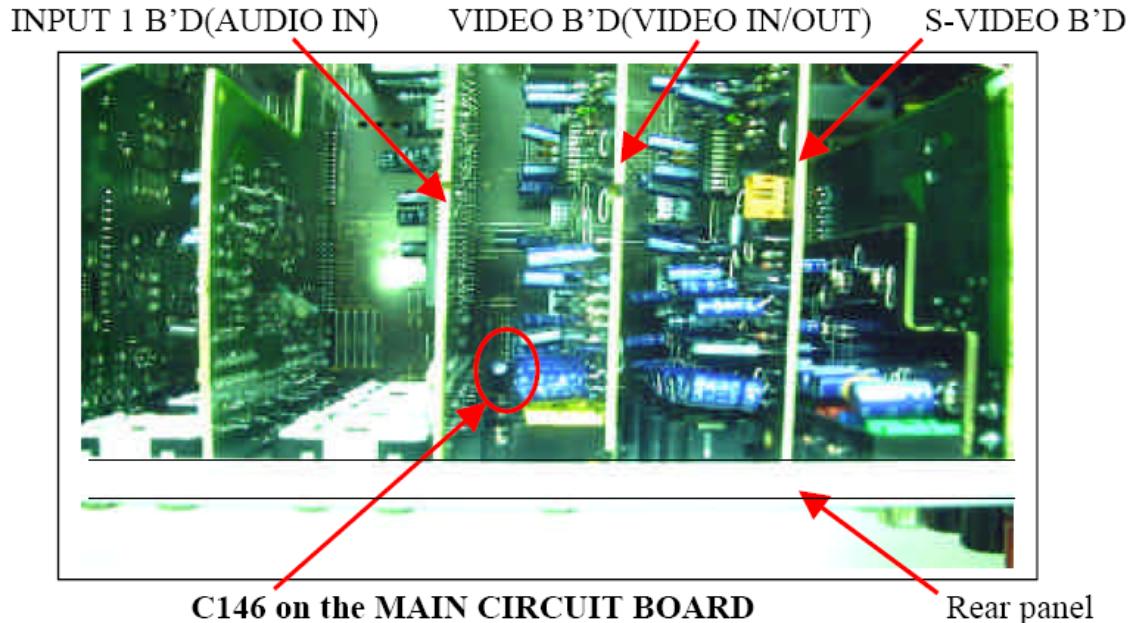
Symptom: A pop noise is heard from the Center speaker, Surround L/R and Surround Center speaker when powering the set ON.

Solution: Change the Electrolytic capacitor C146 (10uF/50V) to a 47uF/16V. C146 is located on the MAIN circuit board.

Ref #	FORMER		NEW	
	Description	Part Number	Description	Part Number
C146	10uF/50V	NA	47uF/16V	EA47601610

- 1) The countermeasure applies to this type of claim only.
- 2) This improvement has been done in production after serial number MZ030227004911 and later. (SR7200/U1B)
