## SERVICE TECHNICAL INFORMATION

REF. NO. SI-95-002

MODEL : AM-F1 , AMD-100

SUBJECT : Notes for replacing the mini disc pickup ASSY

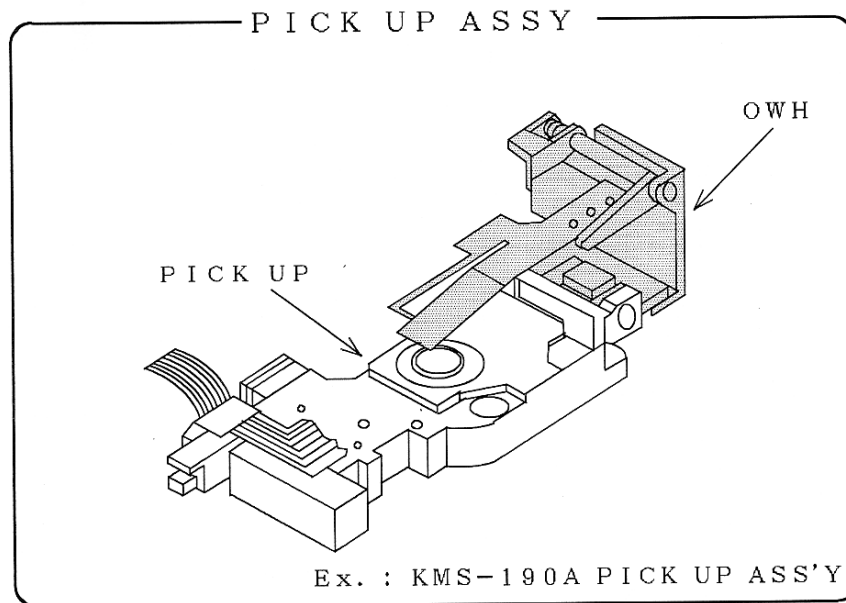
The MD Pickup ASSY has been precisely adjusted at the factory so that the Over Write Head and the pickup join together on the optical path.

CONTENT : For the above models, always replace the ASSY whenever there is a faulty pickup.  
Also, when disassembling or assembling the set, do not disassemble the pickup ASSY.
