SERVICE TECHNICAL INFORMATION

REF. NO. : SI-95-010
CUSTOMER RELATION & SERVICE DIV.

MODEL : AM-F1

SUBJECT : Extension service JIG wire for repair

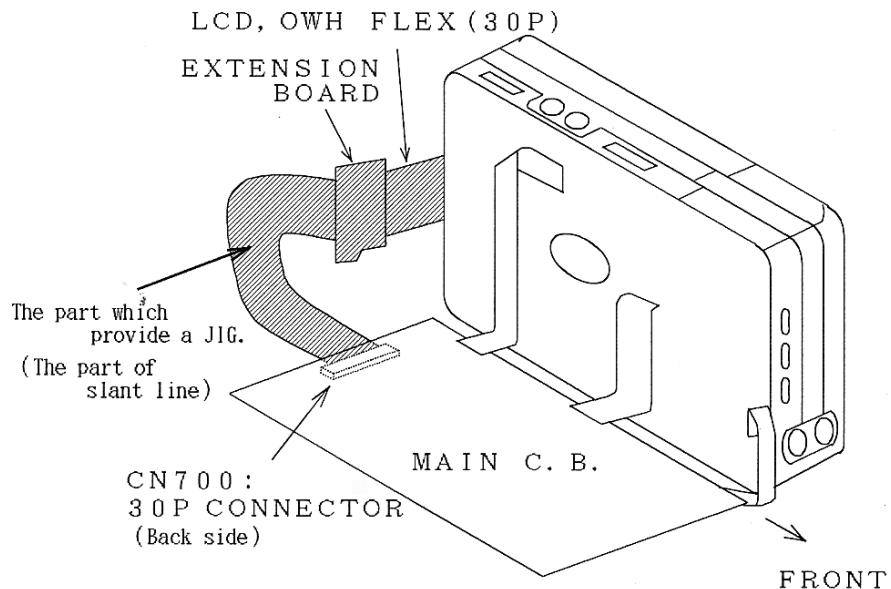
CONTENTS: To improve the service-ability, an extension JIG wire will be provided.
The connection method is as shown in the following figure.

- * AM-F1 does not work when the IC700 of main PCB and control IC of LCD are disconnected.
- * If the display indicate failure occur during use of extension JIG, please confirm contact of connecting points of connector and solder work at the extension board.
