# Service Technical Information

| MODEL NO. | AM-F70 / F65 |
| SUBJECT | "Caution!" display appears. |

REF.No. :G - 99 - 019 - E0

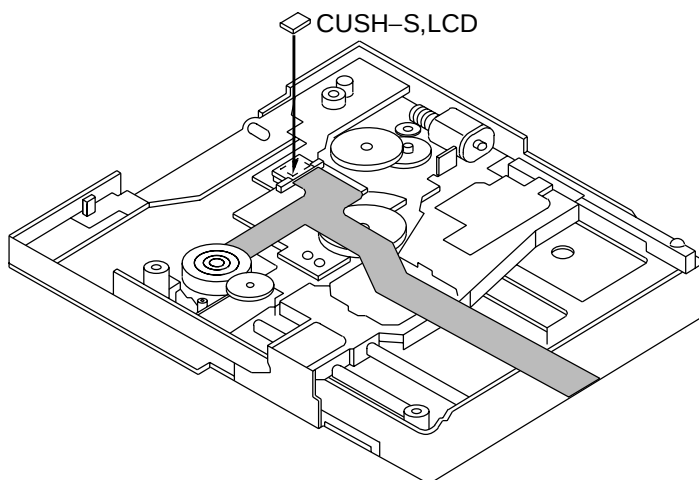
Fig. 1

This symptom occurs when  $\mu$ -COM fails to detect on/off of OWH UP(S50)/DOWN(S51) SW.

- If on/off detect of a switch fails even though the OWH position detect switch is pressed:  
Replace the detection switch with new one.
- If the lever runs on to OWH UP SW(S50) (See Fig.1):  
Remove the lever away from the switch, and then affix a cushion (CUSH-S, LCD) on to the connector of PWB, MECH (CN50).

If that is the case, replace the two switches, S50 and S51 with new ones.
