# Service Technical Information

| MODEL NO. | AM-HX50 / HX55 |
| SUBJECT | Come off screw of HP JACK |

REF.No. :G – A0 – 011 – E0

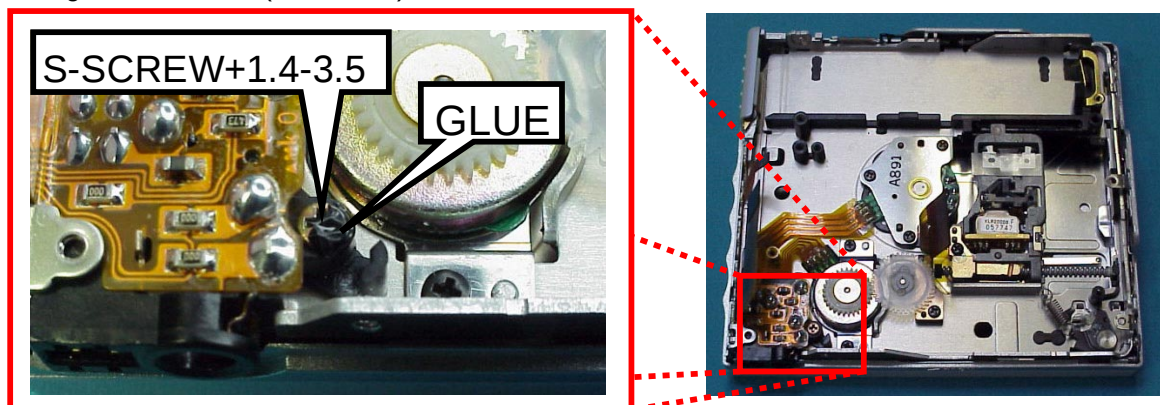
For the above mentioned products, the screw holding the HP JACK are occasionally lost. When this screw dislocate, it attach to the spindle motor or to the magnets of the PICK UP, causing possible NO PLAY.

Replace the screw holding the HP JACK with the Parts Code listed below and glue it on. Use glue No. 1600B(No.1620B).

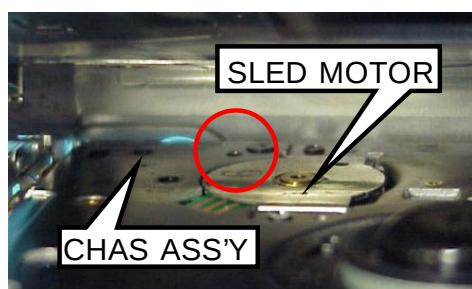
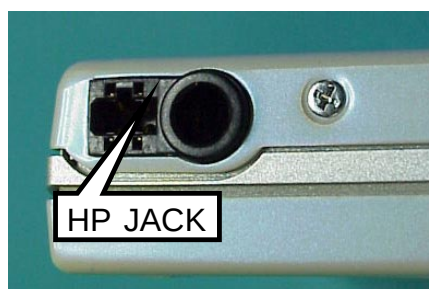
1. Don't fasten too tightly the screw to fix the HP JACK.
  - (1)Be sure that the screw don't protrude from the chassis.
  - (2)Be sure that stress is not applied to the HP JACK.

- 2.Don't get glue on the sled motor or gears.
