SERVICE BULLETIN #7003 - SEPTEMBER, 1987

TO: ALL HARMAN KARDON WARRANTY STATIONS  
MODEL: CXO-1 ACTIVE CROSSOVER  
SUBJECT: ELECTRICAL NOISE

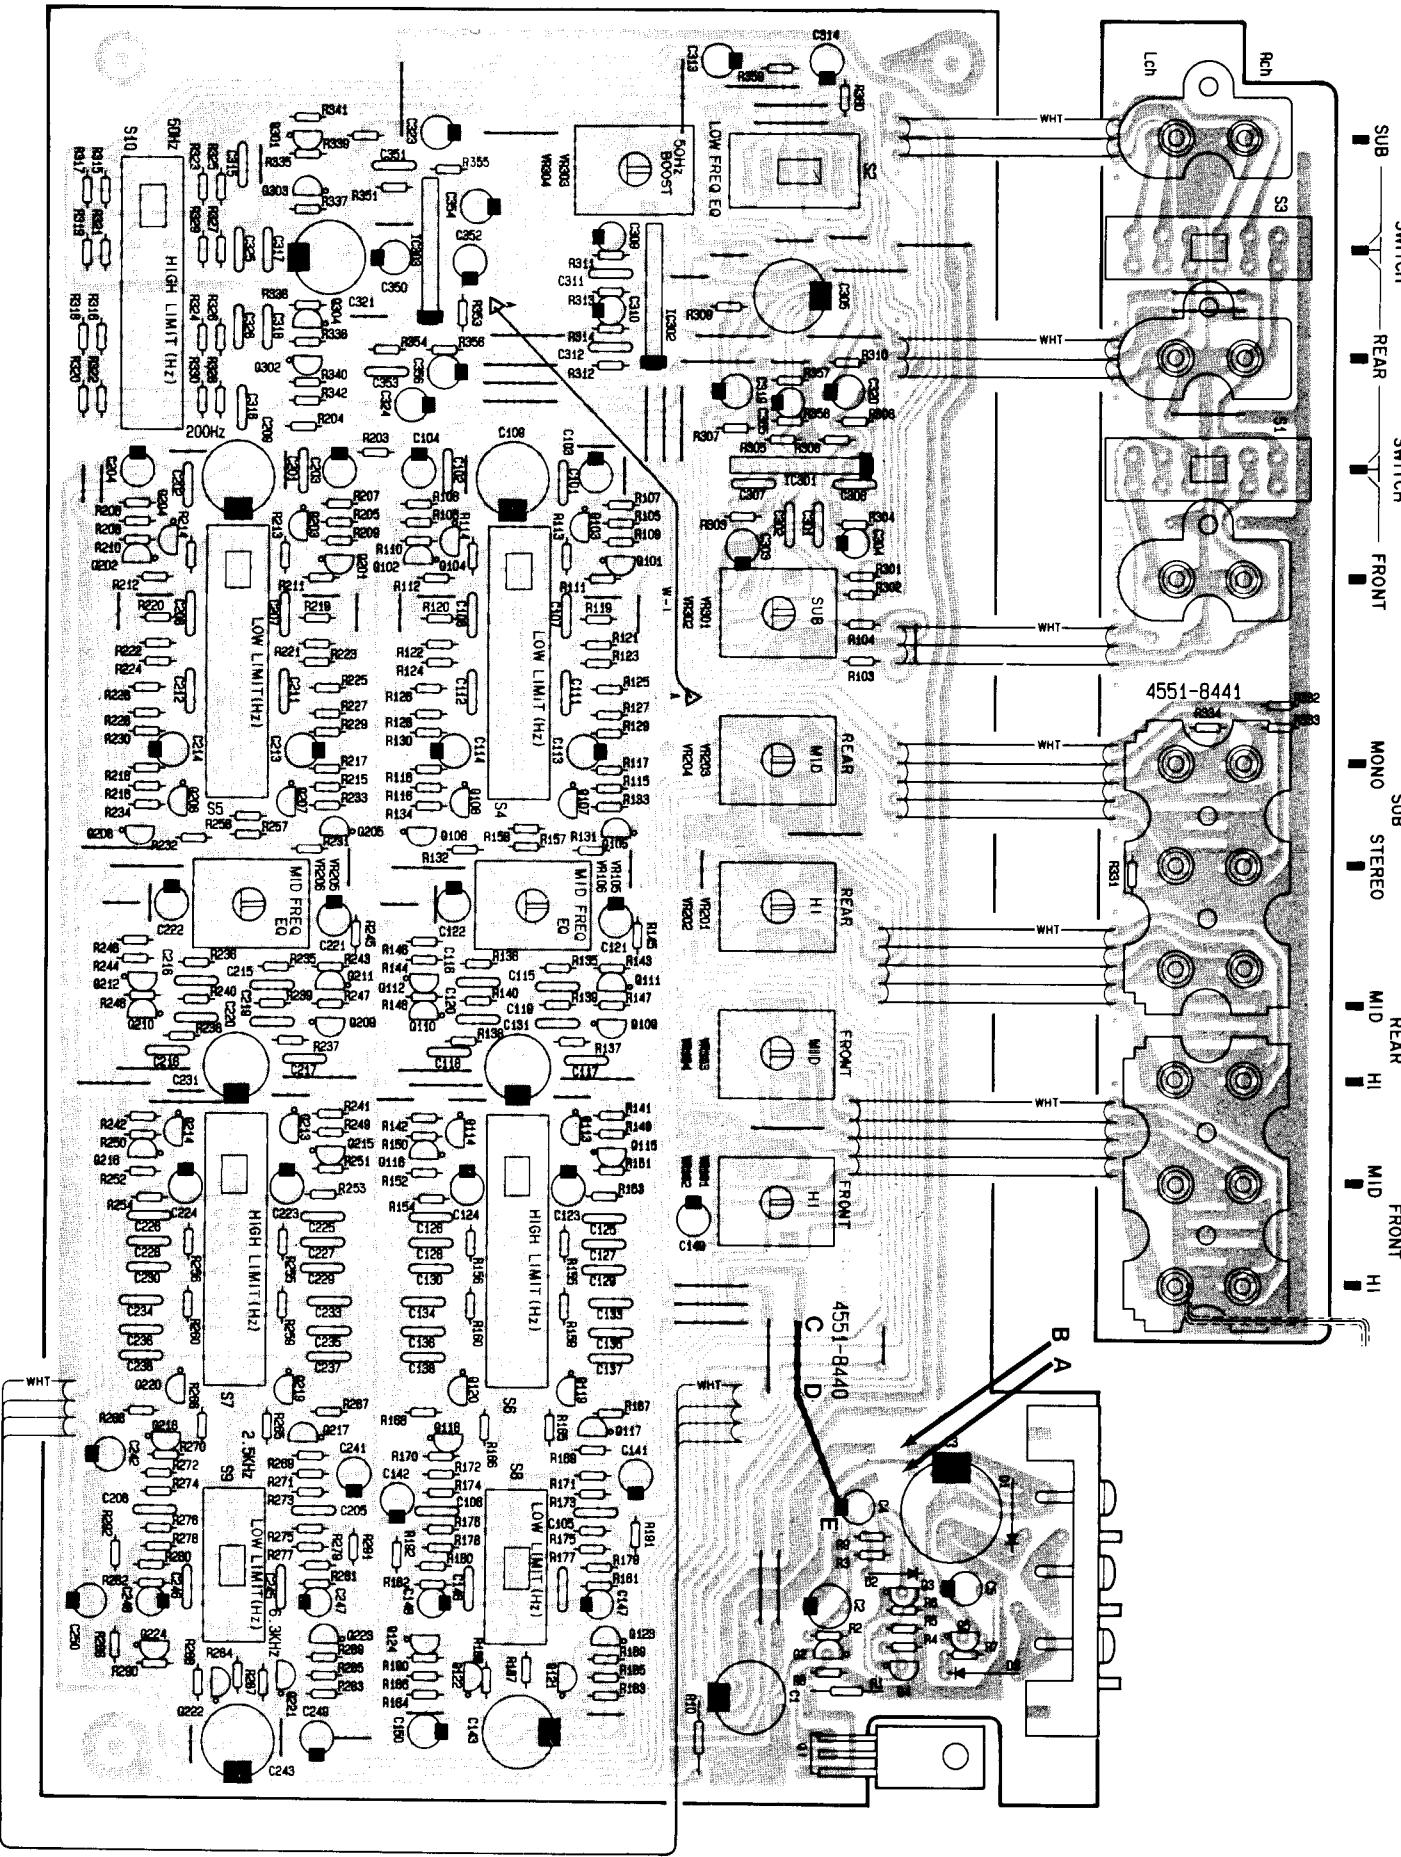
## WIRING DIAGRAM

In complex car audio installations there is the possibility of "ground loops". Ground loops are created by multiple ground connections of various electrical components installed in different locations of the car. Currents flowing through the connecting wires and the metal chassis of the car can generate voltages and due to the "ground loops" DC and AC voltages will develop between the chassis and the ground side of input terminals of electronic components. Gain stages in amplifiers amplify these signals and as a result, electrical noise, generated by electrical components in the car such as a fan motor, wiper motor, ignition coil and the alternator, etc., can become audible in loudspeakers. When installing audio components in cars, special care must be taken to avoid "ground loops".

In the event you receive from a customer a CXO-1 active car crossover with the complaint "electrical noise", we recommend you perform the modification indicated in this bulletin. This modification will improve the car power supply noise-rejection of the CXO-1 for automotive audio systems which have a moderate amount of "ground loop" related electrical interference.

1. Remove the main printed circuit board from the CXO-1.
2. Cut the foil at points "A" and "B".
3. Insert from the component side of the printed circuit board a jumper wire into the existing holes "C" and "D". Solder this jumper wire.
4. Solder on the foil side of the printed circuit board an insulated wire between points "D" and "E".
5. Re-assemble and test the CXO-1.
