RDC-7 With THX-ULTRA-2

Addition or omission of parts.

When servicing the DSP of RDC-7 with the optional THX ULTRA-2 upgrade, make sure to refer to this page as well.

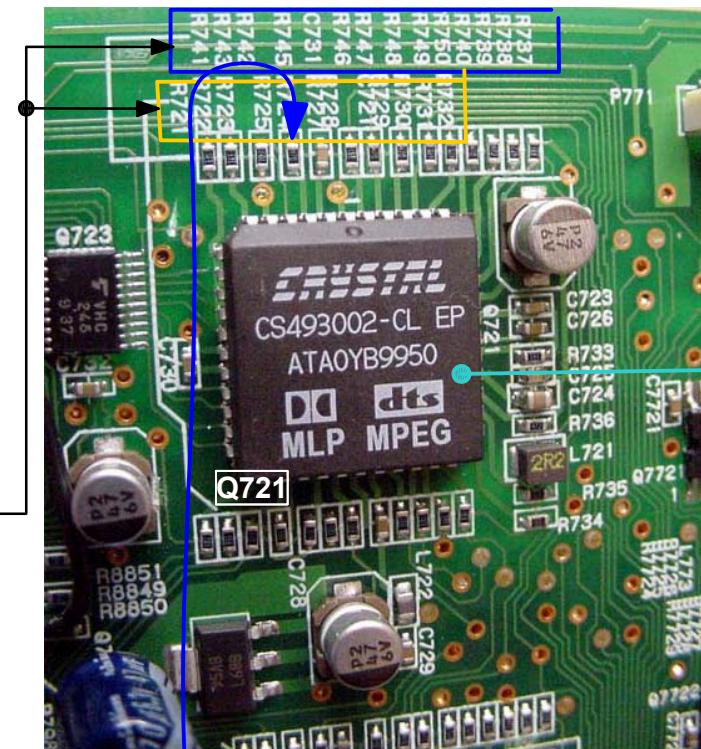
Parts location ID listings in Blue block at the top are for Q721 corresponding to PIN 1~6 and 40 ~ 44. The parts location listings within the yellow block correspond to the SM components associated to Q721 pin# 18 ~ 28. As the arrow indicates, a wire from a removed R768 solder landing that connects to IC Q761 pin #22 location (below) is connected to R745 which is also connected to pin#3 of IC Q721.

Note: All connections at Q761 are in direct relation to the IC pins while at Q721 connection will be through the referenced resistor which is in series to the IC pin.

Jumper wire from Q761 Pin#22 to Q721 pin R745 of Pin mostly black in color.

Do Not attempt to modify the hardware of a none THX-ULTRA-2 unit assuming THX-Ultra will work. The upgrade requires software also. Since the upgrade is sold separately as an option, this information must be treated as supplemental technical information for those units having such an upgrade already in place.

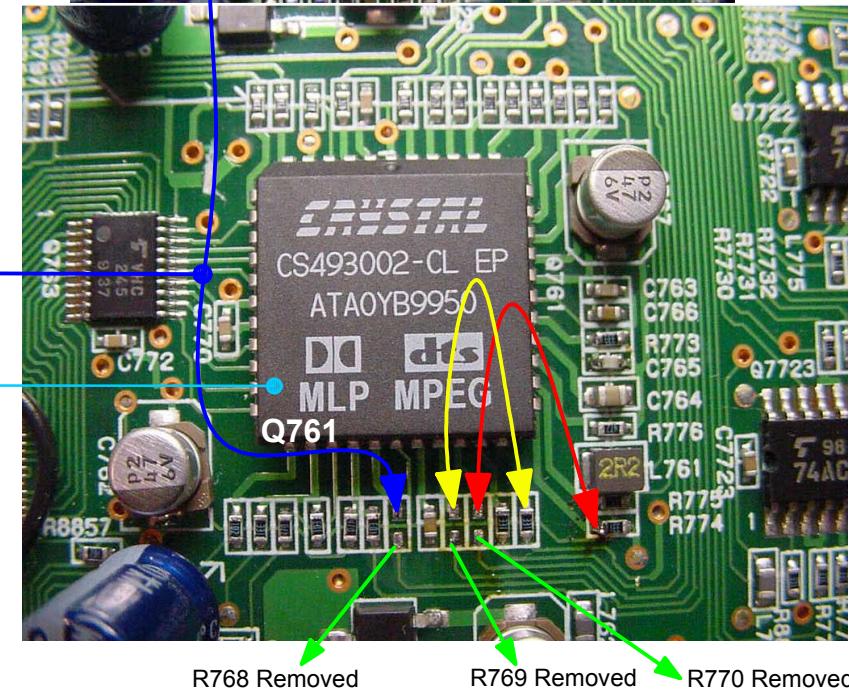
Post processing DSP IC Q761

R768, R769 and R770 may be found to have been removed following the optional THX ULTRA-2 upgrade. Jumpers are in place as illustrated in the picture with Red and Yellow lines.
