## **Service Bulletin**

**No. :** MZ07-017

**Model:** MA-9S2

**Subject:** Audible Pop noise

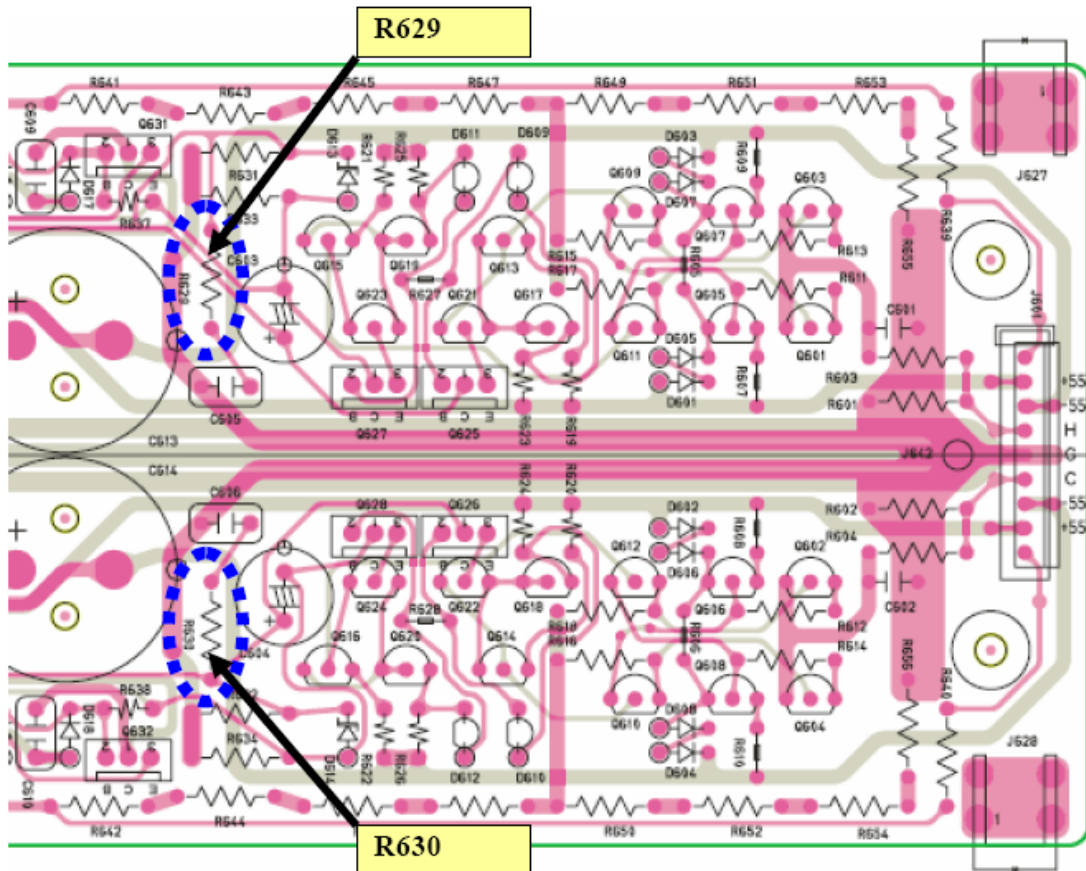
**Symptom:** The product can generate a pop noise when powered on/off. The problem tends to occur when the unit is switched on/off while connected to the SC-7S2 with a balanced cable.

**Solution:** 1. Replace the 10 ohm resistor with a jumper at each of the R629 and R630 sections on the MAIN PWB (P601).  
2. Solder and bond a 220pF to the Land Pad of R521 and R522 on the rear of the INPUT AMP PWB (P501).

1. Replace the R629 and R630 (both 10 ohms) on the MAIN PWB (P601), with a 10mm-long jumper:
