## Service Bulletin

No. : MZ03-005

**Model:** SA8260

**Subject:** Improvement to playability of CD and Super Audio CD

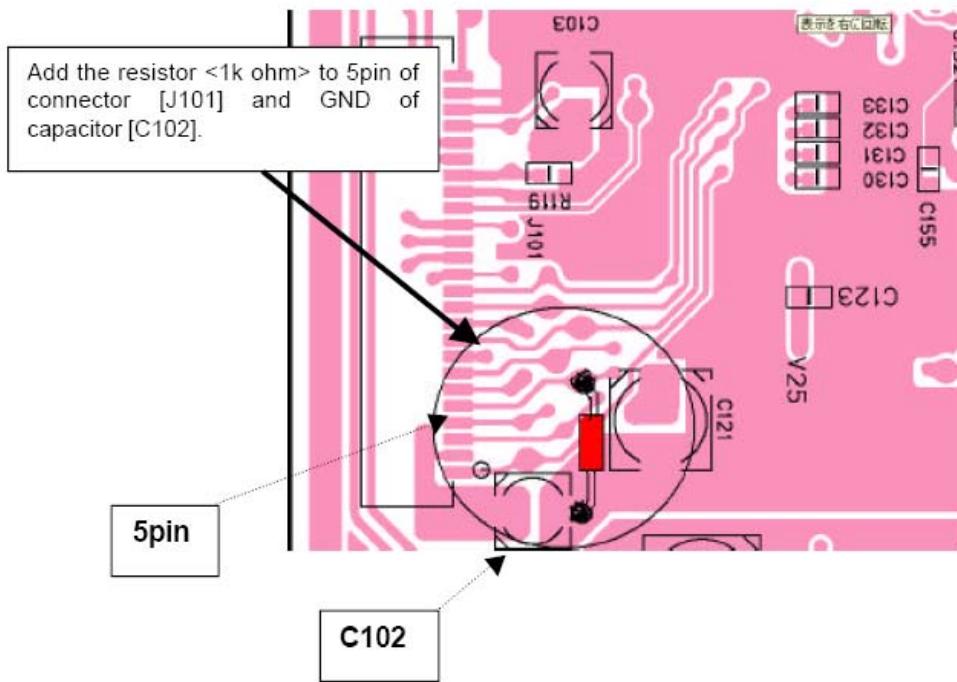
**Symptom:** Will not read TOC, will not start playback, the sound skips with some CD's and Super Audio CD's.

If the LOT number is from 06 to 18, Please apply the following solution.

If the LOT number is from 01 to 18 (only). Replace the servo MPU (Micro Processor Unit) [Q125] with the latest one <Drv Ver. 01.34> (Part No. HU01AKY12F) on the [PV16] PCB.

1. Press and hold the [OPEN/CLOSE] and [SKIP/FF] buttons, then connect the power plug.
2. Press the [SKIP/FF] button twice, then the version will show "Drv Ver XX.XX" on the display.2) [01 to 18 Lot only] Add the resistor <1k ohm> (Part No. GD05102160) on the [PV16] PCB as follows;

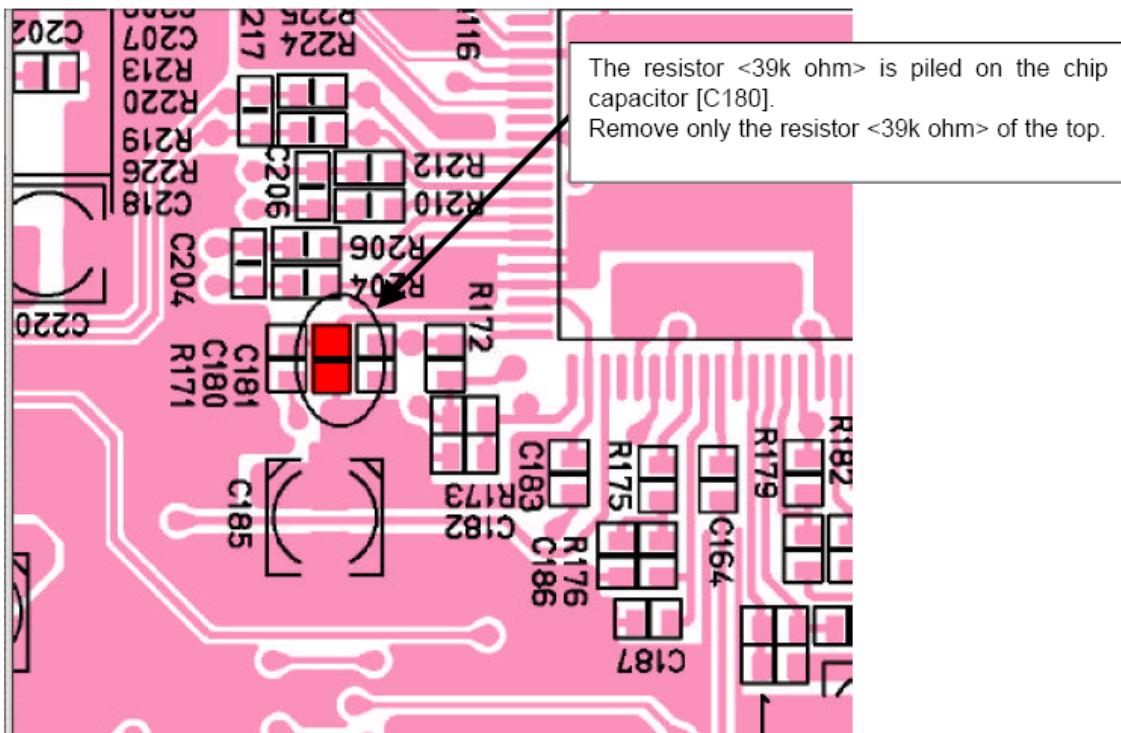
If the LOT number is from 19 to 20, (The LOT number is "##" of serial number "MZxxxxxx##xxxx".) Please apply the following solution:

If the Lot # is 19 to 20 only (The LOT number is "##" of serial number "MZxxxxxx##xxxx".) do the following: Replace the servo MPU (Micro Processor Unit) [Q125] with the latest one <Drv Ver. 01.34> (Part No. HU01AKY12F) on the [PV16] PCB.

1. Press and hold the [OPEN/CLOSE] and [SKIP/FF] buttons, then connect the power plug.
2. Press the [SKIP/FF] button twice, then the version will show "Drv Ver XX.XX" on the display.2) [19 to 20 Lot only] Remove the resistor <39k ohm> on the [PV16] PCB as follows;
